Hazard Alert

Road roller reverse travel

Government
of South Australia
SafeWork SA

NOV 2012
HA0017-1

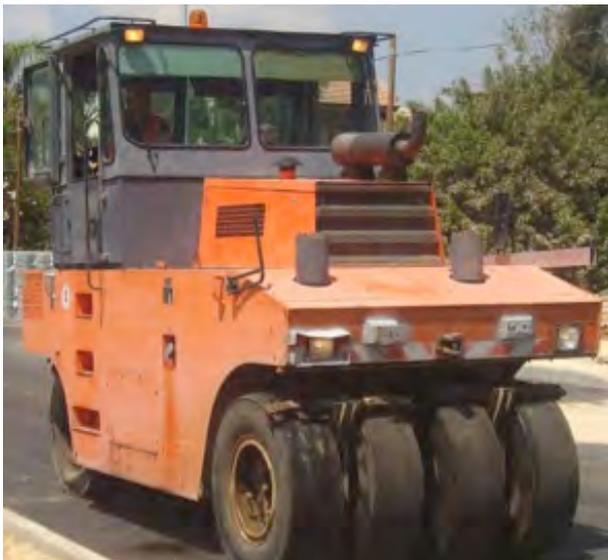
Example of a multi-tyred road roller
